OHIO HISTORIC INVENTORY

2. County Butler 5. His	oric or Other Name(s) East Dining Hall		BUT-0251 8-01
		5. Historic or Other Name(s) East Dining Hall	
6. Specific Address or Location North Fisher Drive	19a. Design Sources	35. Plan Shape Rectangular	2. County Butler
6a. Lot, Section or VMD Number	20. Contractor or Builder Carl Conradt & Sons, Hamilton, Ohio 21. Building Type or Plan Other Building Type 22. Original Use, if apparent	36. Changes associated with 17/17b Dates: 17. Original/Most significant construct

7. City or Village Oxford	College/University	37. Window Type(s) Steel	Еа
9. U.T.M. Reference Quadrangle Name: Oxford 16 695524 4375653	23. Present Use College/University	Casement 38. Building Dimensions	resent or H Ist End
Zone Easting Northing 10. Classification: Building	24. Ownership Public 25. Owner's Name & Address, if known Miami University	39. Endangered? NO By What?	4. Present or Historic Name(s. East End Building

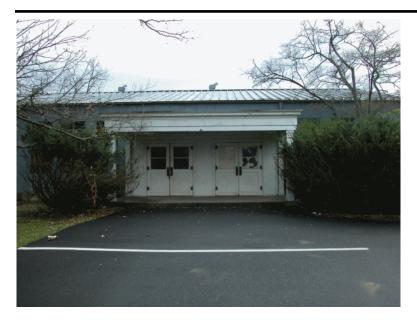
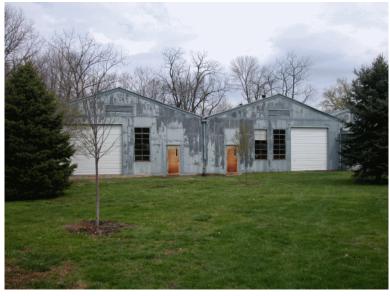
The East End building is a prefabricated steel structure built on a reinforced concrete slab foundation. Windows are the original hopper steel casement sash, the siding is sheet metal panels laid vertically, and the roof is standing seam metal. Off center in the facade is an entrance porch with flat roof and square wood posts at the ends, a modification from the original three sets of paired posts. The porch shelters a pair of double entry doors set within a projecting wood-framed vestibule. There are three gables on side elevations, showing the original construction of the building in three rectangular gabled sections. The east side remains as originally built, with 15 steel casement windows. On the west side, garage and man doors have been added to accommodate the current use, which appears to be storage.
