## OHIO HISTORIC INVENTORY

1. No. BUT-02481-01 4. Present Name(s) Emerson Hall				1-01
2. County Butler	5. Historic or Other Name(s) Emerson Hall			248
6. Specific Address or Location 699 Maple Avenue		19a. Design Sources	35. Plan Shape H-shaped	2. County Butler
6a. Lot, Section or VMD Number		20. Contractor or Builder Frank Messer & Sons 21. Building Type or Plan Other Building Type 22. Original Use, if apparent	36. Changes associated with 17/17b Dates: 17. Original/Most significant construct 17b.	anty unity

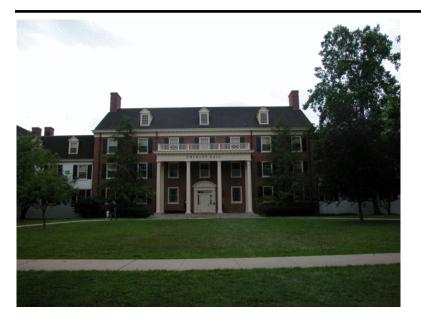
Emerson Hall is a 3-1/2 story red brick building, roughly H-shaped. A three bay section on each side of the central block is one story shorter in height, and the brick has been painted white. The central entrance features a solid wood door with a large surround. The surround contains sidelights and a transom and has a curved pediment. A two-story porch covers the entrance. It is supported by simplified Corinthian columns and has a geometric balustrade and cornice modillions. The west elevation has a secondary entrance with a small one-story porch, with cornice modillions and a triglyph and metope entablature. It is supported by Doric columns. The solid wood door has sidelights. A bay window, on the first floor, is also present on the west elevation. Other features of the building include 8-over-8 window sash, Flemish bond brick pattern, splayed-brick lintels, fanlight windows, cornice modillions and pedimented dormers.

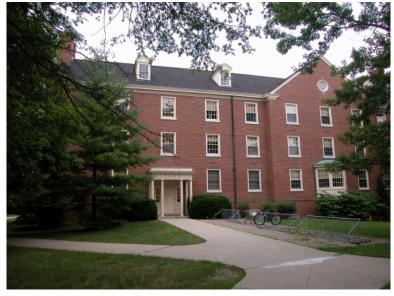
8. Site Plan with North Arrow

Emerson Hall is in the southern portion of the campus. Along with Tappan and Morris Halls, it forms a small quad, just east of the southern section of the large South Quad.
