OHIO HISTORIC INVENTORY

| 1. No. BUT-00165-01 REV | | 4. Present Name(s) Irvin Hall | | 5-01 BUT-0016 |
| 2. County Butler | | 5. Historic or Other Name(s) Irvin Hall | | |
| 6. Specific Address or Location 400 East Spring Street | | 19a. Design Sources | | 2. County Butler |

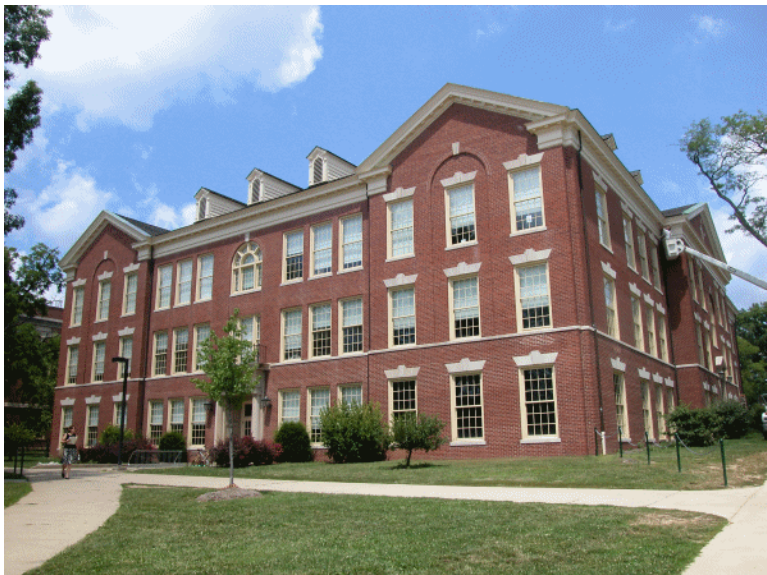
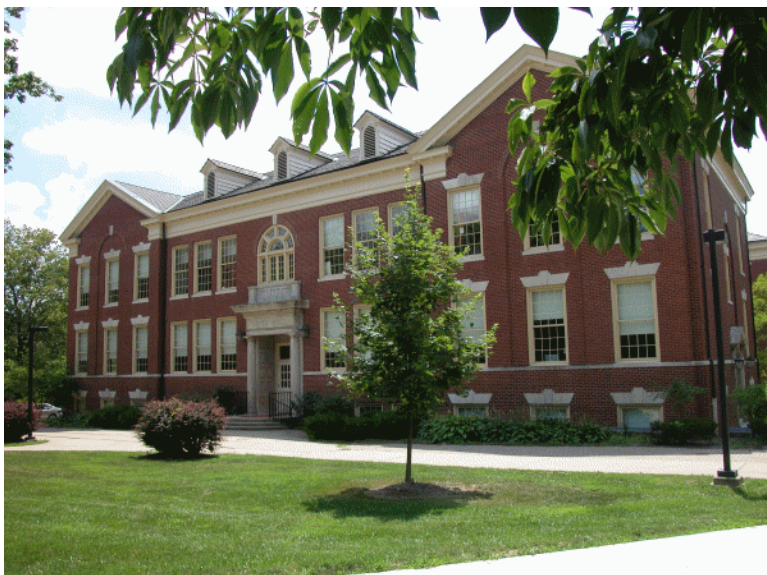
| 42. Further Description of Important Interior and Exterior Features (Continued on Reverse if Necessary) Irvin Hall is constructed in a U-shape, with significant facades on three sides, a gabled roof with small gabled dormers, a wide cornice and frieze, and a stone water table at the foundation. The north elevation serves as the main facade, although the south elevation also contains an important entrance feature. The facade has gabled end pavilions separated by pilasters from a central section containing the main entrance. The gabled pavilions have cornice returns, windows with splayed stone lintels and keystones, and a 2-story blind arch containing the middle window. The center section contains seven bays, with a central round-arched window on the second floor and a recessed entry door with classical limestone surround at the first floor. The east-facing center wing has a long elevation with a pedimented pavilion at its center. The center bay indicates the location of a stair, with a large round-arched window at the landing level. The entrance here has a classical gabled stone entry surround and a fanlight above the double door. The door is reached by a set of steps. | | | | 6. Specific Address or Location 400 East Spring Street |
