OHIO HISTORIC INVENTORY

1. No. BUT-02480-01		4. Present Name(s) Tappan Hall		0-01 BUT-0248
2. County Butler		5. Historic or Other Name(s) Tappan Hall		
6. Specific Address or Location 650 South Patterson Avenue		19a. Design Sources		2. County Butler
6a. Lot, Section or VMD Number		20. Contractor or Builder Frank Messer & Sons

1. No. BUT-02480-01	4. Present Name(s) Tappan Hall
2. County Butler	5. Historic or Other Name(s) Tappan Hall

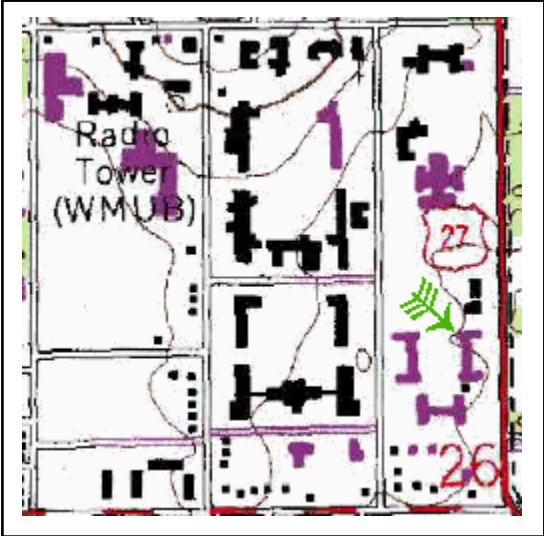
8. Site Plan with North Arrow

44. Description of Environment and Outbuildings (See #52)				
<p>Tappan Hall is in the southern portion of the campus. Along with Emerson and Morris Halls, it forms a small quad, just east of the southern section of the large South Quad. The quad is informally called MET (Morris, Emerson, Tappan) by students.</p>

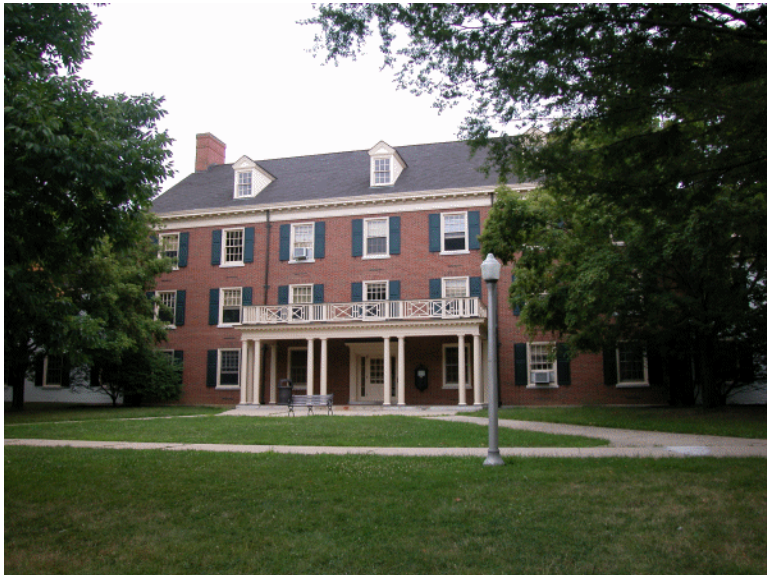
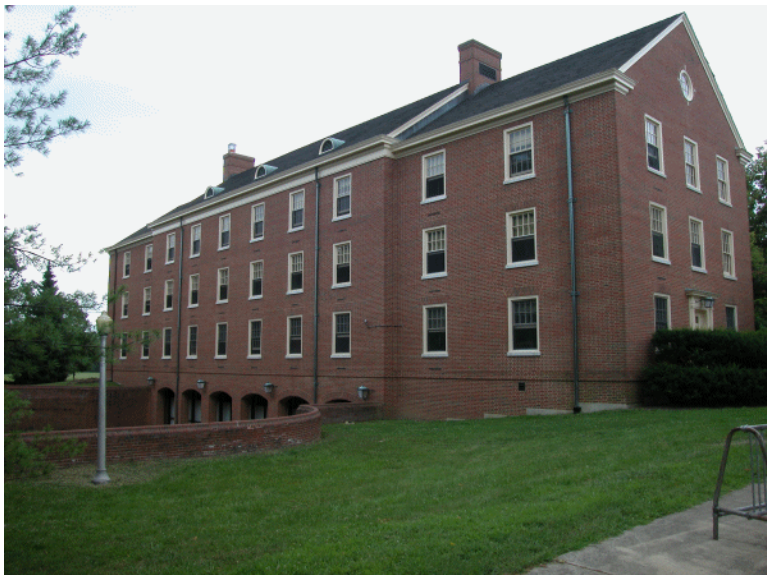
53. Affiliated Inventory Numbers: Historic (OHI) Archaeological (OAI)
42. Further Description of Important Interior and Exterior Features (Continued on Reverse if Necessary)				
<p>Tappan Hall is a 3-1/2 story red brick building, roughly H-shaped. A three bay section on each side of the central block is one story shorter in height, and the brick has been painted white. The facade has a two-story porch with Doric columns, cornice modillions, and simple balustrade. The solid door has sidelights, and large surround with a curved pediment. The rear elevation faces the quad, to the west. It has a central entrance that features a nine-light wood door with sidelights. The door surround has a large, plain entablature. A one-story porch covers the entrance. It is supported by Doric columns and has a geometric balustrade and cornice modillions. The south elevation has a row of segmentally arched openings at the basement level. They correspond to curved brick walls extending out from the building, which encloses open space below grade. Other features of the building include 8-over-8 window sash, Flemish bond brick pattern, splayed-brick lintels, fanlight windows, cornice modillions and pedimented dormers.</p>
